Loose Drive Belts & Blue Pulleys

Is Your Charging System Not Putting Out As Much As It Used To?
 -Check The Drive Belt, Alternator Pulley, and Belt Tensioner-

How Oil Leaks Can Affect a Charging System

Engine oil, power steering and hydraulic fluid leaks can decrease an alternator output to zero

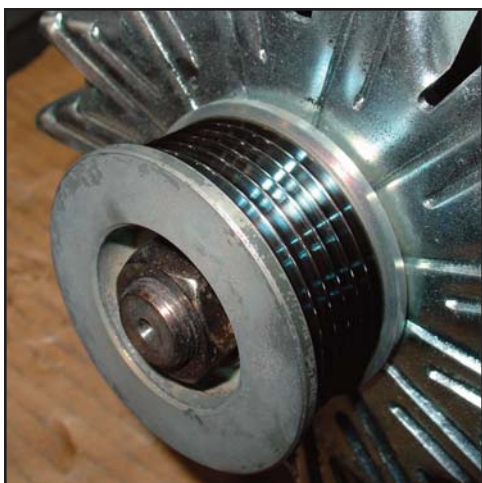
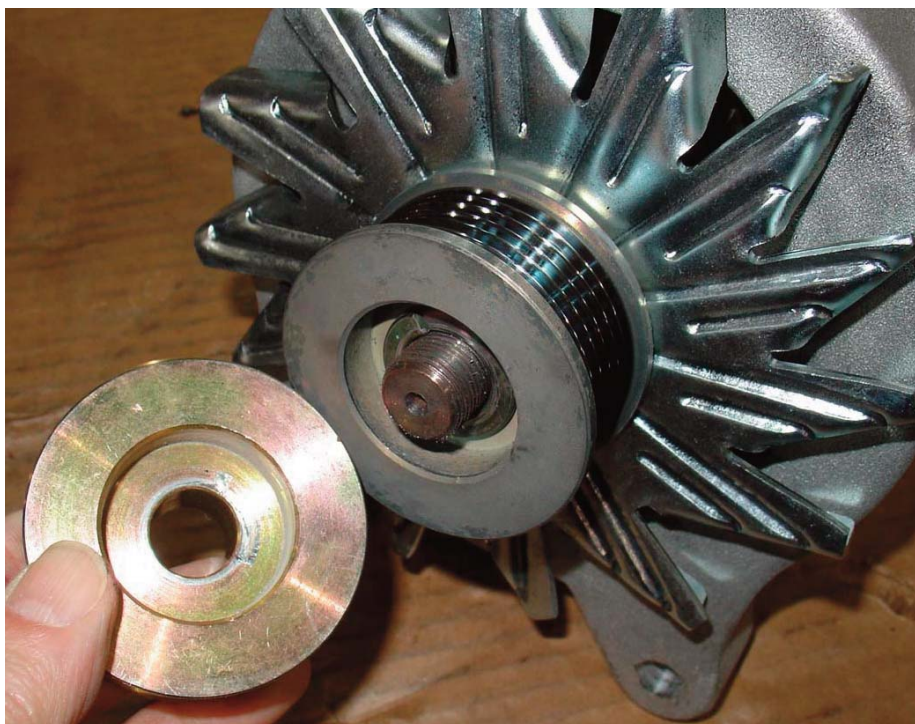
In this case, the belt was causing so much heat that the plating was being cooked off of the drive pulley. Look at the difference in color between a regular pulley and the one with the loose belt. Note the blue color in the belt contact area. The heat had begun to transfer to the rotor shaft as it was also turning blue. The PennTex front bearing was able to take the heat only because of the superior quality of the bearing and the quality of the grease in the bearing. When the alternator was tested with a tight belt, even though it had been subjected to all this heat, the output was right where it should be. Check your belts and drive belt tensioner to see if your system output is being reduced by a loose belt. Don't wait too long...

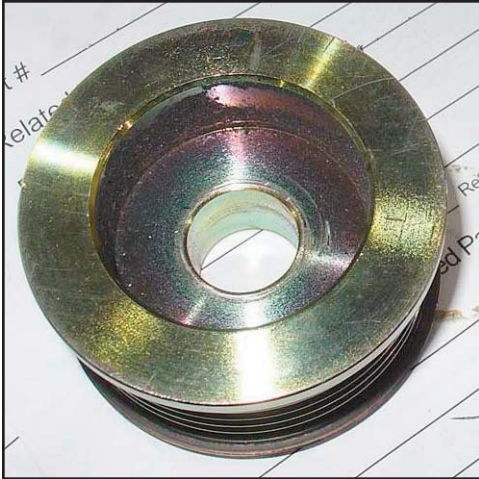
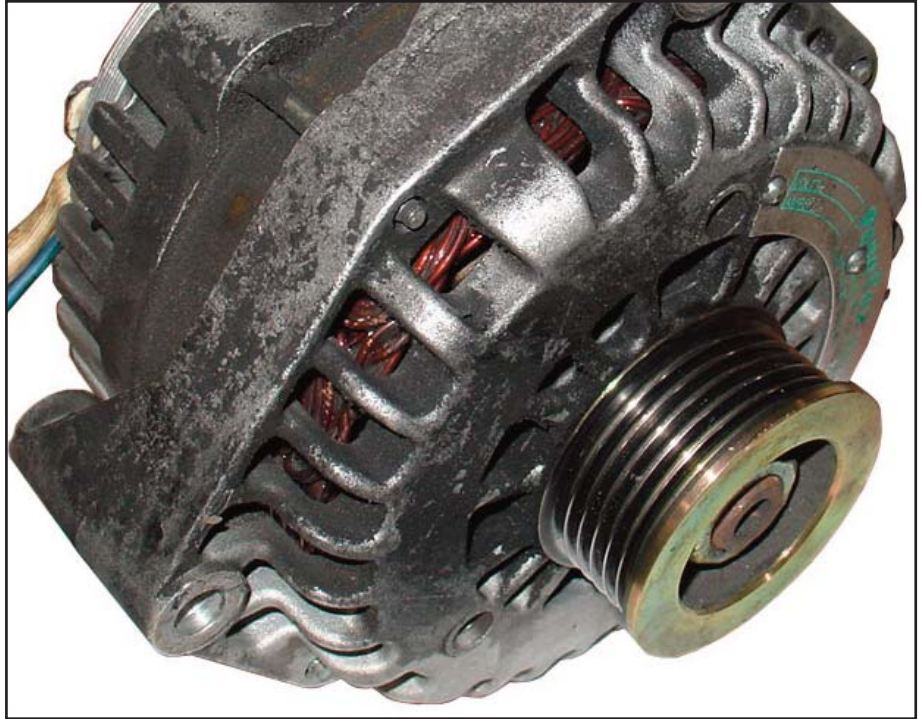
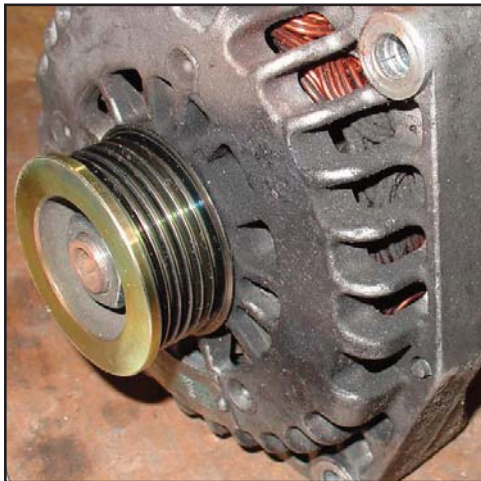
Note the blue color on the inside of the alternator pulley on the top left. Some kind of fluid is getting on the drive pulley of these alternators causing the serpentine belt to slip. The pulley wants to stand still but friction from the belt makes it turn. Resistance against the belt increases as charging system demand increases. The heat comes from the pulley slipping against the belt. The pulley surface that the belt rides on turns almost black from heat. In some cases, the alternator gets saturated with oily fluid that gets in the brushes and slip rings. This is not good. After a clean-up the alternator on the right went back to charging, but heat and oil had already damaged it too much to make it any part of it useable in the field. Damage like this is classified as an external cause of alternator failure and in most cases is not covered under warranty.
