## POSSIBLE PX-5TD / GLOW PLUG RELAY INTERFERENCE ON A FORD 7.3 DIESEL WITH A PX-520TD

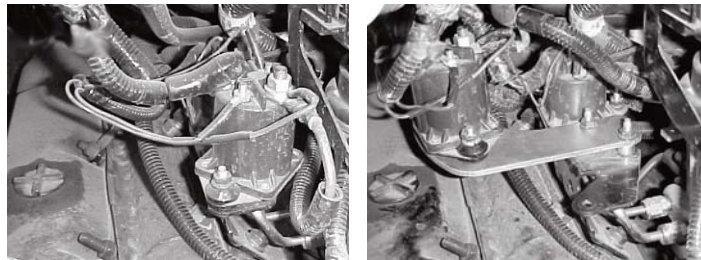
An issue has come to our attention when a PX-5T PennTex alternator is replaced with a PennTex PX-5TD-230 or 250 on a Ford 7.3 diesel. Some vehicles may have a clearance problem between the PX-5TD alternator rear case and the front glow plug relay on 2000 and up Ford 7.3 diesel engines if our relocation bracket wasn't installed.

The PX-5TD-230/250 has the negative diodes installed in the rear case making the rear case thicker than the earlier design PX-5T.

Glow plug relay relocation brackets were sold as part of the earlier PX-520TO complete kit for this engine, but in some cases, the relocation brackets were not installed. Instead of relocating the relay, one of the relay cables was simply bent or "moved out of the way". This was not our suggested installation method. Also, a regular PX-520T kit may have been installed and the installer may not have been aware that a glow plug relay relocation bracket was available.

Front Ford 7.3 diesel glow plug relay before and after relocation with a PX-5505 bracket kit.

The part number for a PennTex glow plug relay relocation bracket kit is PX-5505. It is available from our Warehouse Distributors nationwide. Installation of this kit gives plenty of room behind the PX-5TD alternator.
