Drivability Issues with a Ford 6.8 Gas V-10 E-Series Van: it dies at stops, going around corners or decelerating, and it just had the throttle body or Throttle Position Sensor (TPS) replaced.

SERVICE BULLETIN

RE: Ford 6.8L E-Series cutaway bus chassis with PennTex Charging Systems

Bulletin Date: 09-03-2014, Updated 07-18-2014

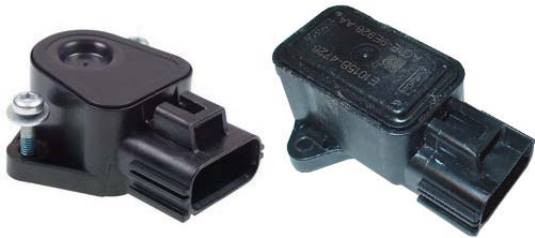
The Two Throttle Position Sensor Styles

Potentiometer Style:
"Triangular" shape
Spring-loaded

Hall-effect Style:
Rectangular shape
Not spring-loaded

The PX-7011 TPS Shield is designed for the rectangular Hall-effect style sensor only. The other style TPS is not affected by magnetic interference and does not need one.

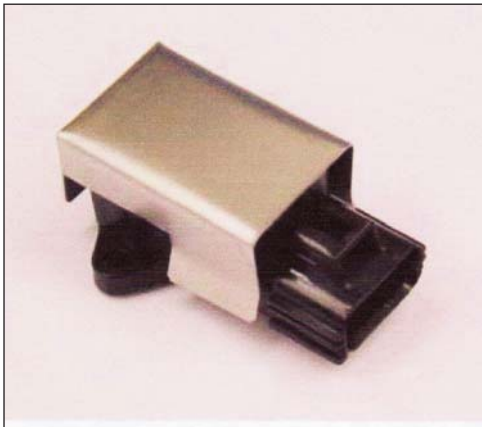
PX-7011 TPS Shield w/ Tape

The PX-7011 TPS Shield Kit is designed for Ford 6.8 L V-10 applications where the PennTex alternator is in close proximity to the Throttle Position Sensor.

To install, remove the red film from the double-sided tape and push firmly on to the TPS.
