Loose Drive Belts & Blue Pulleys

Is Your Charging System Not Putting Out As Much As It Used To?
 -Check The Drive Belt, Alternator Pulley, and Belt Tensioner-

How Oil Leaks Can Affect a Charging System

Engine oil, power steering and hydraulic fluid leaks can decrease an alternator output to zero

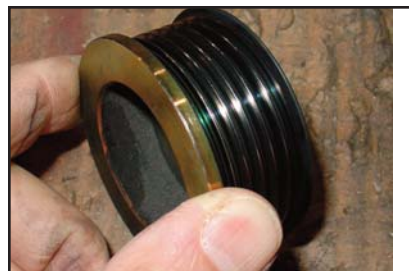
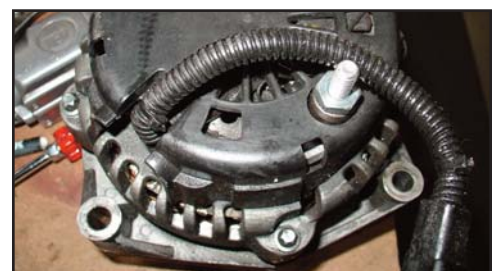
Note the blue color on the inside of the alternator pulley on the top left. Some kind of fluid is getting on the drive pulley of these alternators causing the serpentine belt to slip. The pulley wants to stand still but friction from the belt makes it turn. Resistance against the belt increases as charging system demand increases. The heat comes from the pulley slipping against the belt. The pulley surface that the belt rides on turns almost black from heat. In some cases, the alternator gets saturated with oily fluid that gets in the brushes and slip rings. This is not good. After a clean-up the alternator on the right went back to charging, but heat and oil had already damaged it too much to make it any part of it useable in the field. Damage like this is classified as an external cause of alternator failure and in most cases is not covered under warranty.
