Drivability Issues with a Ford 6.8 Gas V-10 E-Series Van: it dies at stops, going around corners or decelerating, and it just had the throttle body or Throttle Position Sensor (TPS) replaced.

SERVICE BULLETIN

RE: Ford 6.8L E-Series cutaway bus chassis with PennTex Charging Systems

Bulletin Date: 09-03-2014, Updated 07-18-2014

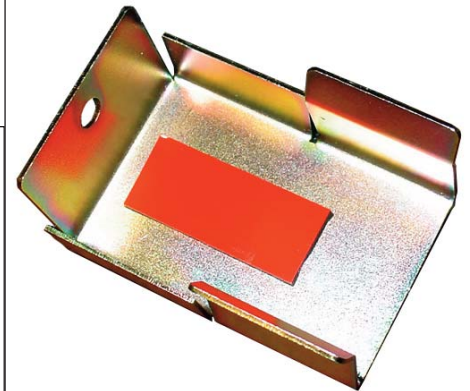
PX-7011 TPS Shield w/ Tape

The PX-7011 TPS Shield Kit is designed for Ford 6.8 L V-10 applications where the PennTex alternator is in close proximity to the Throttle Position Sensor.

The PX-7011 TPS Shield is designed for the rectangular Hall-effect style sensor only. The other style TPS is not affected by magnetic interference and does not need one.

To install, remove the red film from the double-sided tape and push firmly on to the TPS.
