TITLE/DESC. GENERIC WIRING DIAGRAM FOR A PX-5 ALTERNATOR WITH A PX-4000 REGULATOR

REPLACING A SINGLE-POSITIVE-POST PX-5 WITH A DUAL-POSITIVE-POST PX-5

RECOMMENDED CHANGE ON ANY VEHICLE WITH A PENNTEX ALTERNATOR

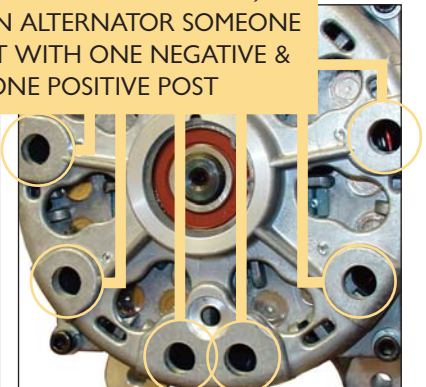
HOW TO TELL A DOUBLE POSITIVE POST PENNTEX ALTERNATOR FROM A SINGLE POSITIVE POST PENNTEX ALTERNATOR

1) Look for the "D" in the Model Number

2) Look for the strap

3) Look for diodes in the rear housing
